A railway bridge in the Netherlands faced a significant challenge after a truck collided with its structure, causing visible deformation to the bottom flange of the main girder—a critical component of the bridge. The deformation raised concerns about potential crack growth and initially a repair was scheduled - but it would result in excessive downtime and substantial expenses, making it a costly solution.

To avoid unplanned downtime and expensive repairs, Villari collaborated with the bridge's owner to implement a continuous monitoring system. The sensors were strategically placed on the deformed flange, a process that required minimal installation time and no surface preparation. The sensor system detects crack growth by monitoring changes in the ferro-magnetic field of the steel structure, providing real-time data on any structural developments.

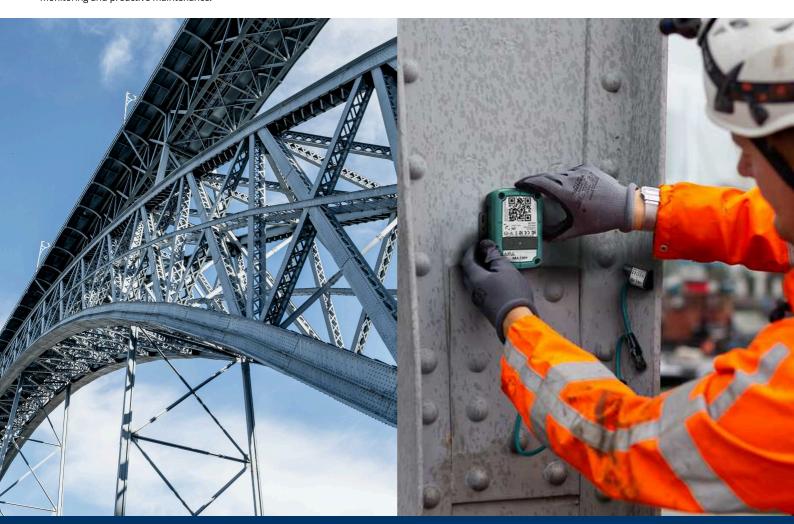
Figure 1 (Left) This image illustrates a steel bridge. (Right) Villari's crack detection sensors are typically installed at critical stress points, to ensure continuous monitoring and proactive maintenance.
